# Landslides in Ireland

**A Report of the Irish  
Landslides Working Group**

**June 2006**

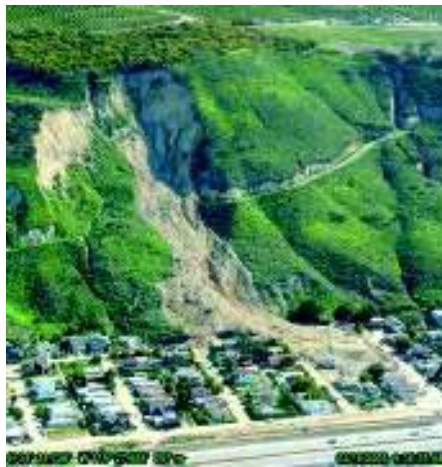
**Plate 1.1** La Conchita, California 1995, 2005  
(<http://landslides.usgs.gov/>)

Landslides are a major geohazard in many countries across the globe, along with earthquakes and volcanoes. Indeed many landslides are triggered by earthquakes or volcanic eruptions. These landslide events lead to massive losses in terms of human life and infrastructure. Landslides are a major area of scientific research by both geologists and engineers. At La Conchita, California (Plate 1.1) a landslide which was initiated in 1995 reactivated in heavy rain in 2005 killing ten people.

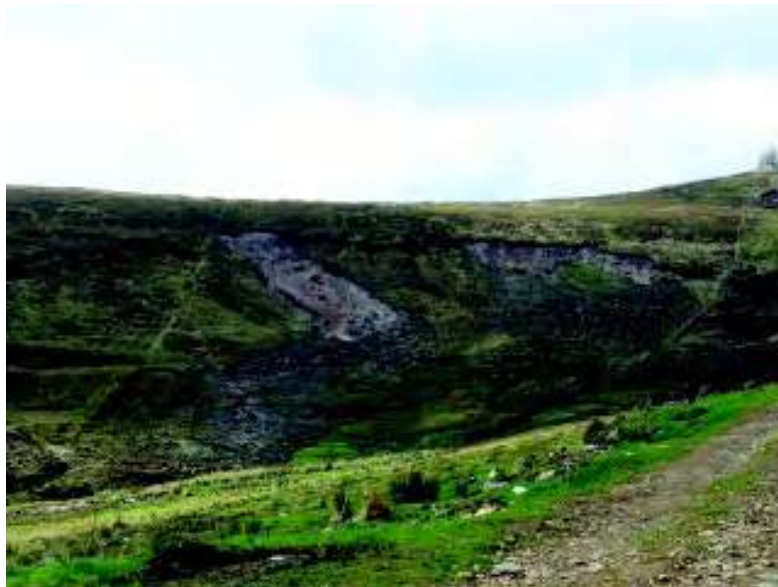
**Plate 1.2** Pollatomish Landslides, Co. Mayo

Events in late 2003 at Pollatomish in Co. Mayo (Plate 1.2), and Derrybrien in Co. Galway, where there was considerable damage done but thankfully no loss of life, have highlighted the paucity of information on landslides in Ireland. There is no collated body of data either at the regional or national scale. It was clear that much work needs to be done to assess the scale of the problem historically and also to assess the susceptibility of areas to landslide hazard in the future. This has direct relevance to the sustainable development of the landscape in terms of housing, infrastructure etc. and is therefore an important issue for the planning process.

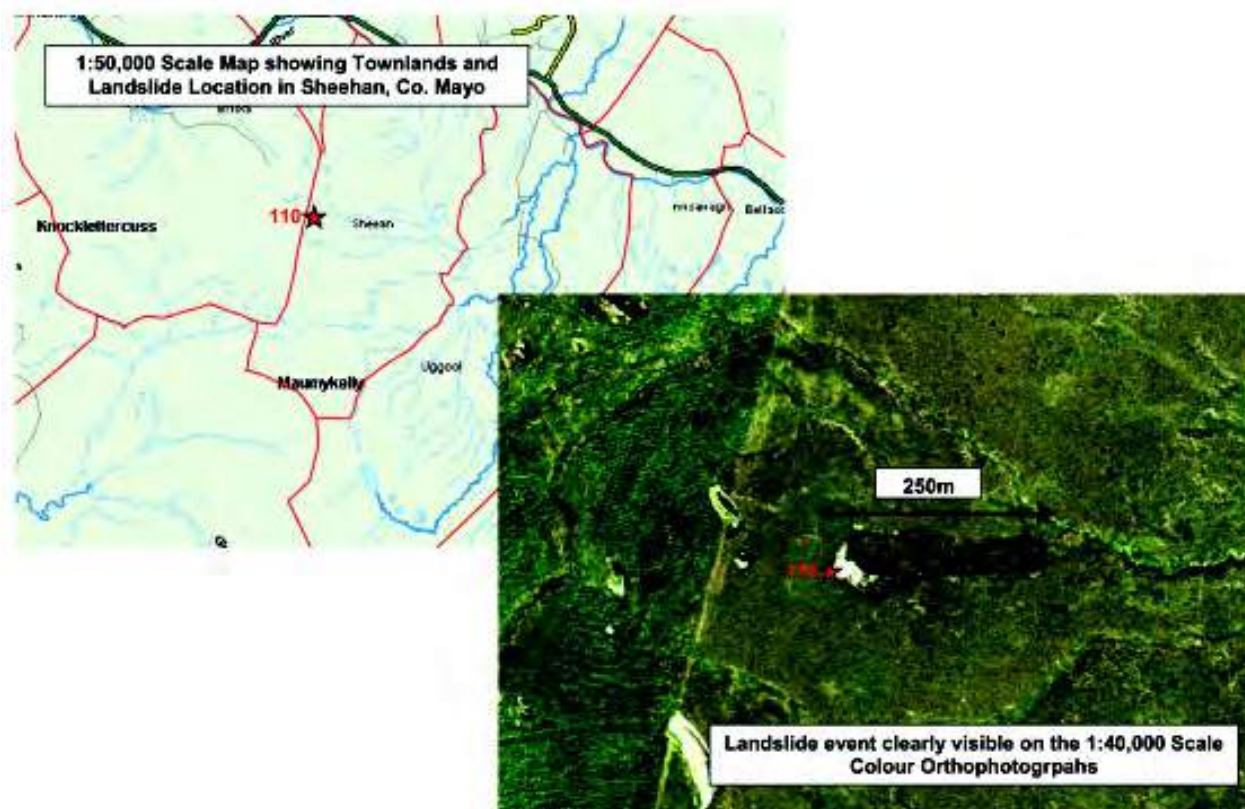
These instances are just a small example of the additional information that can be gathered on an event by using the GIS, thus showing that the desktop research on landslide events is a highly valuable step into the continuing research and understanding of landslide events in Ireland.

Fig. 3.1 Two images showing the use of GIS spatial and topographic datasets to locate a landslide event

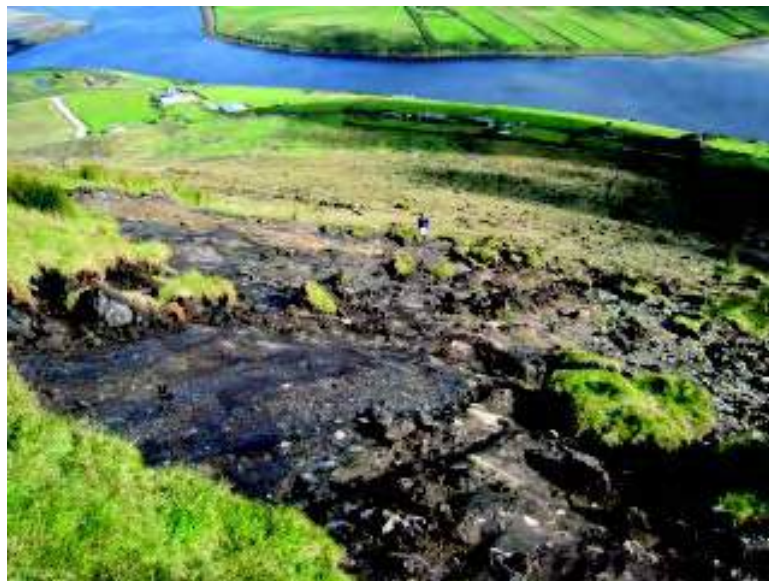
Several different failure mechanisms have been identified (Tobin, 2003). On the upper steep slopes there was shallow translational sliding of peat and weathered mineral soil, resulting in the exposure of very smooth or polished failure surfaces composed of peat and a clayey soil. Further downslope there was shallow rotational sliding of the weathered rock and soil. In addition the huge volumes of water cascading down the slopes created debris flows of peat blocks and weathered rock. This may have equated to sheet flow at the height of the storm. The resultant scatter of debris all across the slopes was very visible from higher elevations. A lot of the debris was eventually channelled into the pre-existing drainage channels causing extensive deepening of these on the lower slopes near the road.

**Plate 3.1** Pollatomish Slide

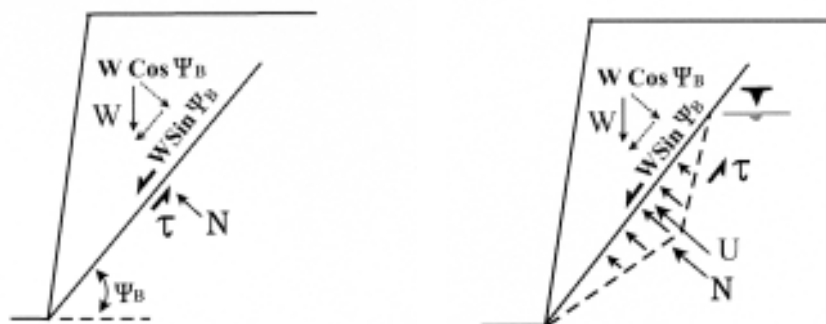
The significance of the various terms can best be appreciated by considering the stability of a wedge of soil or rock as shown on Fig. 4.1 and by assuming that the  $c'$  term is small and can be ignored, which is true of most soils. This wedge type model is one of many failure mechanisms, for example circular, translational, and others, and is used here for illustration purposes only.

Fig. 4.1 Stability of wedge of soil or rock a) dry slope b) with water pressures

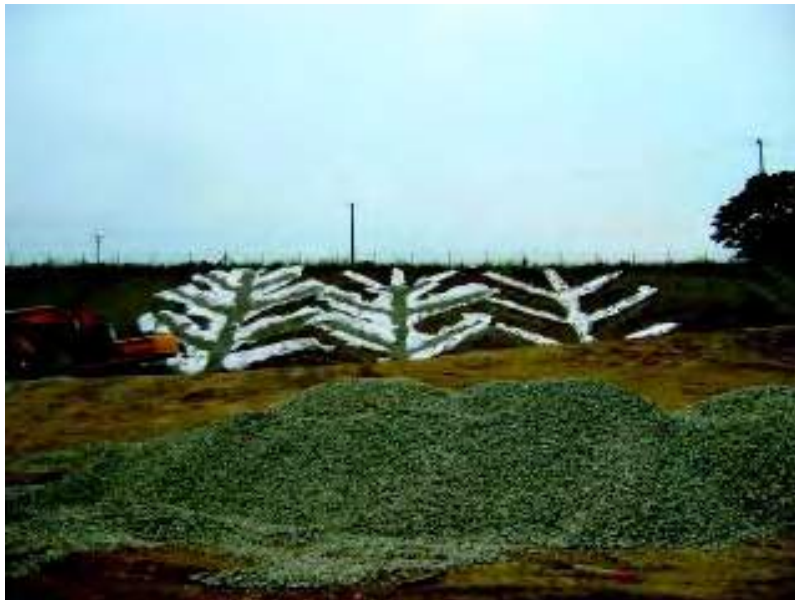
For example, it can be shown that the stable angle of a granular material is equal to  $\phi'$ , which for a typical sand would be about  $30^\circ$  (about 1.75 horizontal to 1 vertical). This reduces to about  $15^\circ$  (about 3.7 horizontal to 1 vertical) with horizontal flow. Many of our Irish soils are of glacial origin and, because of this, their stratification can be very variable with sand layers within typical boulder clays. The boulder clay slopes would typically be stable at a slope of 2 horizontal to 1 vertical, however where there is water flowing from sand layers these form flatter slopes, undermining the upper clays which leads to a slope failure. This process is called internal erosion and is a common cause for instability in slopes of Irish glacial soils. Because of this, herringbone drains (Plate 4.1) are frequently used in the slopes formed by road cuttings to intercept this water flow before it reaches the slope face and hence prevent this type of failure.

**Plate 4.1** Herringbone drainage system being installed in cut slope of glacial till.

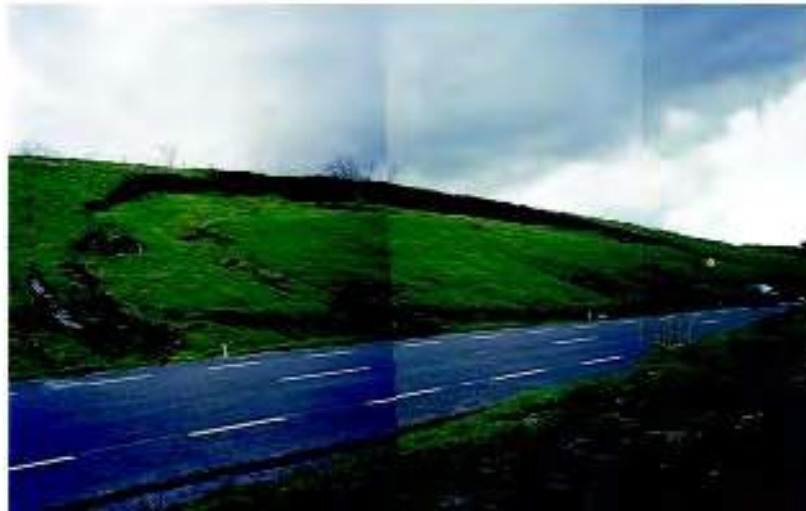
Glaciofluvial and glaciolacustrine deposits are formed by water flowing around the ice margins and into ponds and lakes which were sometimes of considerable extent. In some circumstances these have given rise to layered or laminated silts, clays and sands which can be stiff/compact if the ice subsequently readvanced over these deposits. Instabilities have arisen in slopes formed within these deposits due to the low strength parameters of some of the clay layers, together with water pressures that build up within some of the sand layers. For example, angles of shearing resistance of the order of  $24^\circ$  have been recorded in these soils, with residual angles of shearing resistance of the order of  $10^\circ$ . An example of a rotational/translational failure in glaciolacustrine soil is shown on Plate 4.2.

**Plate 4.2** Slope failure in a glaciolacustrine deposit.

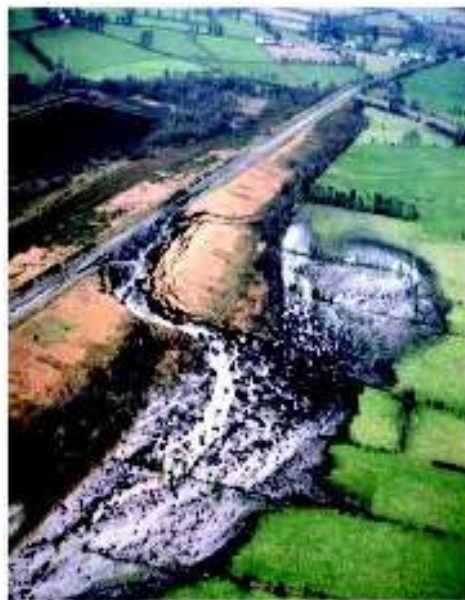
Drying of the peat during prolonged warm weather can reduce its unit weight and increase the risk of uplift. This was likely to have been a contributory factor to the slides at Pollatomish in September 2003. Long periods of dry weather will also induce cracking in the peat, thus providing a flow path for water to reach the weaker zones. It is also likely that such a scenario contributed to the failure of the Grand Canal near Edenderry in 1989 (Pigott et al, 1992). As can be seen in Plate 4.3, the slide resembles a classic shear failure. Lateral water pressure from the canal displaced somewhat buoyant peat. Witnesses to the slides describe a tearing sound as the embankment material separated from its foundation.

**Plate 4.3** Slide on the Grand Canal, near Edenderry (Pigott et al., 1992)

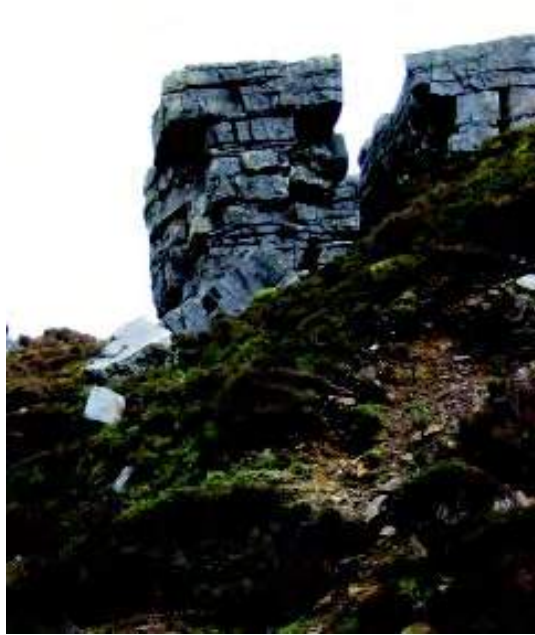
**Falls** are local failures of slopes which are due to weathering of rock, ice pressures or water pressures. These do occur on rock faces from time to time. Topples arise either from water or wind pressures or from a bearing capacity failure of the toe. Slides arise from the same mechanism as for soil except along discrete weak planes in the rock and can be triggered by increases in water pressures along these surfaces during rain as was discussed previously in Section 2 in relation to soil. Rock slides do occur in Ireland, generally related to manmade excavations or on the higher mountain areas where environmental factors are impacting on steep faces. Falls and topples are clearly evident where steep rock faces occur and an example of a potential toppling failure can be seen in Plate 4.4.

**Plate 4.4** Potential toppling failure at Monesk on the Cavan/Leitrim border, also known as Englishman's Mountain. (Photo – Xavier Pellicer, GSI)

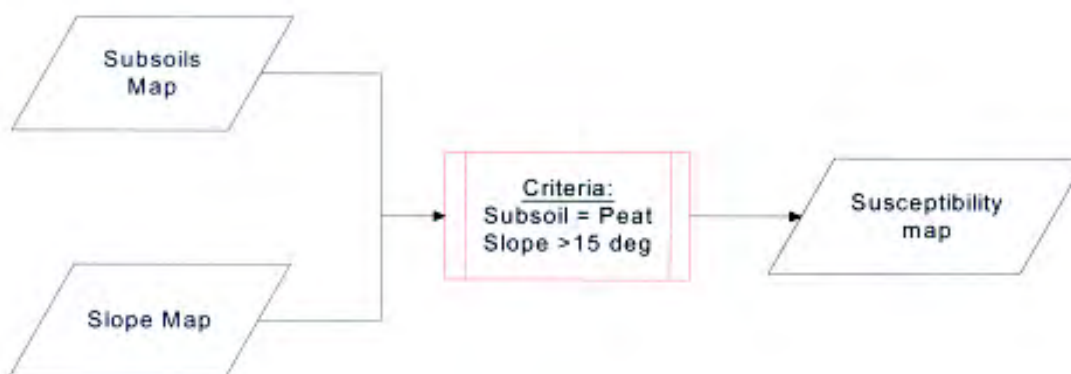
For this initial run, the criteria addressing peat slope angle  $> 15^\circ$  was modelled. All peat mapped in the subsoils map was used in the classification process as shown in Fig. 5.3. The input maps to the classification process are shown in Fig. 5.4. The data was combined in the GIS using established map algebra techniques.

**Fig 5.3** Model schematic for first susceptibility map

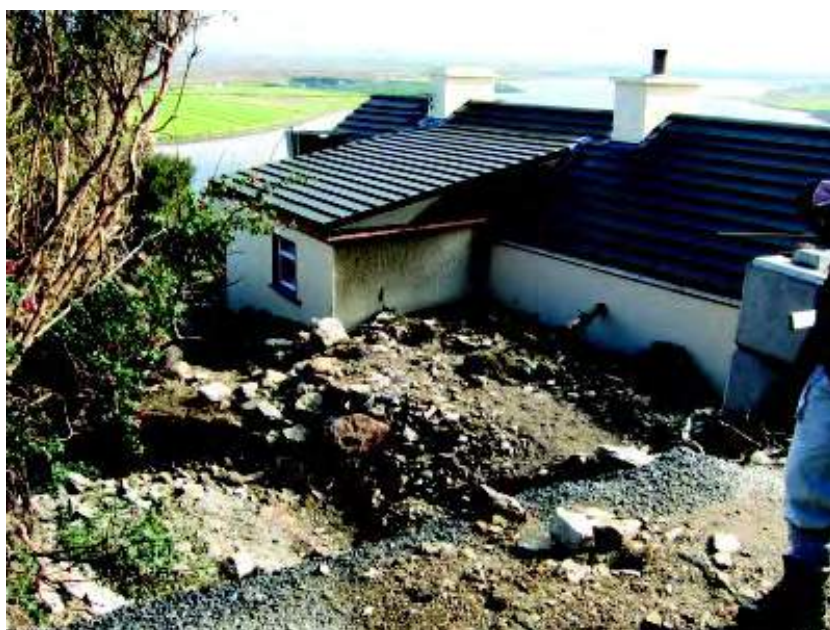
**Plate 6.1** Damaged House at Pollatomish

Most development plans do not contain objectives in regard to either the identification of unstable ground or for regulating development on such land where identified (or known), apart from in coastal areas. This may be due to a number of reasons including the relatively low occurrence of landslides to date, the lack of information on landslide hazard, and the low intensity of development pressure in areas of potential instability. However increasing development pressure, often in remote uncultivated and undeveloped areas, from e.g. wind energy, residential and recreational activity, and also the possibility of an increase in storms and other dramatic weather events (Plate 6.1) due to climate change, may result in an increase in landslide occurrences.

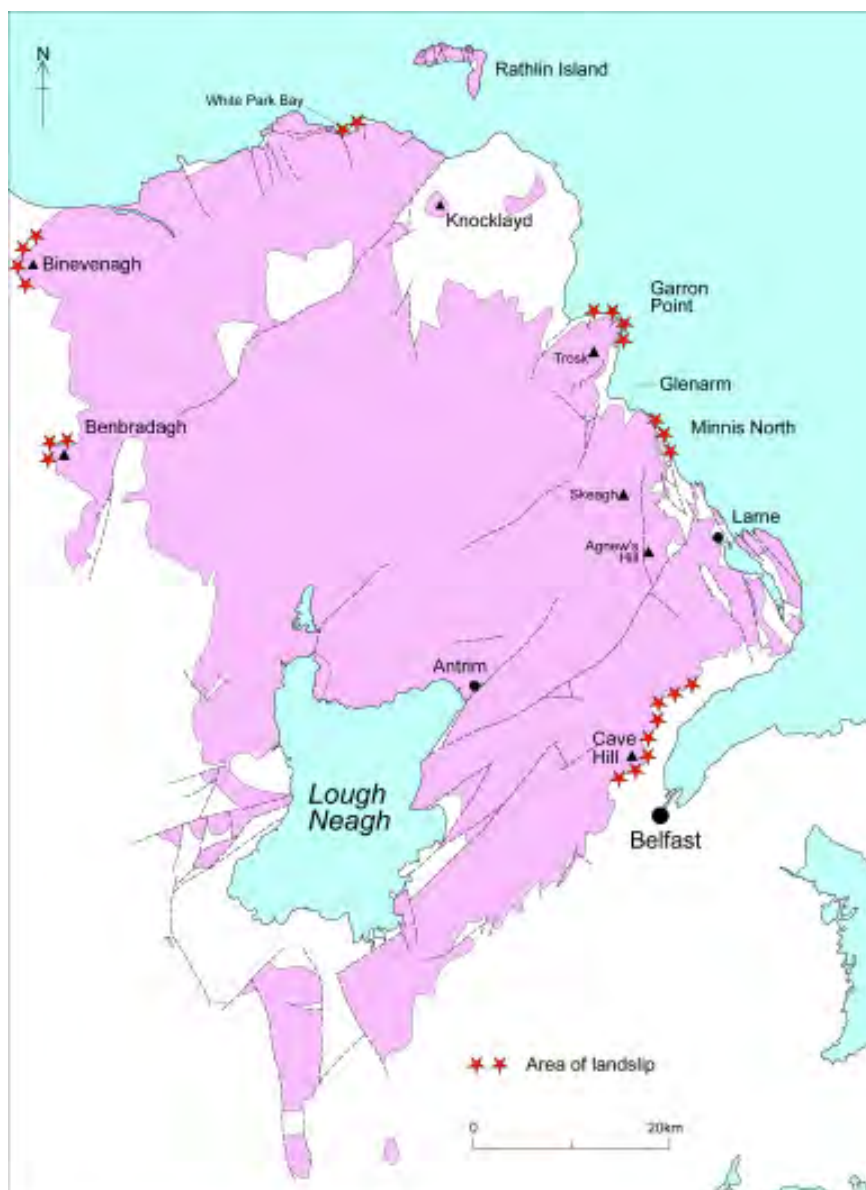
**Fig. 7.1** Principal Areas of Landslides Around the Basalt Plateau (Counties Antrim & Londonderry)

Landslips and associated ground instability are common features around the edge of the basalt plateau in Counties Antrim and Londonderry where they contribute in a large part to the landscape character (Fig. 7.1).

At a number of locations (Fig. 7.1) the edge of the Antrim Basalt Plateau consists of large scale, deep-seated, multiple rotational landslide features. The mechanisms behind this instability are directly related to the geological succession and the geomorphological processes that subsequently sculpted the landscape. The plateau edge is capped by hard “competent” rocks: basalt lavas (Antrim Lava Group, Tertiary) and chalk (Ulster White Limestone Formation, Cretaceous). These rocks overlie softer, less competent, impermeable mudstone: (Waterloo Mudstone Formation, Jurassic and the Penarth Group & Mercia Mudstone Groups, Triassic) (Fig. 7.2 and Plate 7.1).

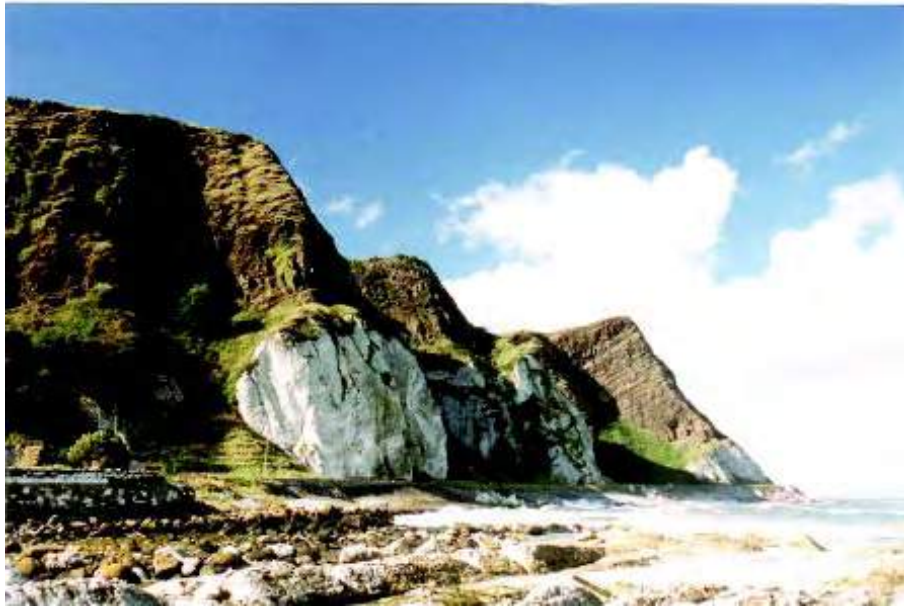
**Plate 7.1** Rotational Landslide (Basalt over Chalk) at Garron Point, Coast Road, Co Antrim.  
(Crown Copyright)

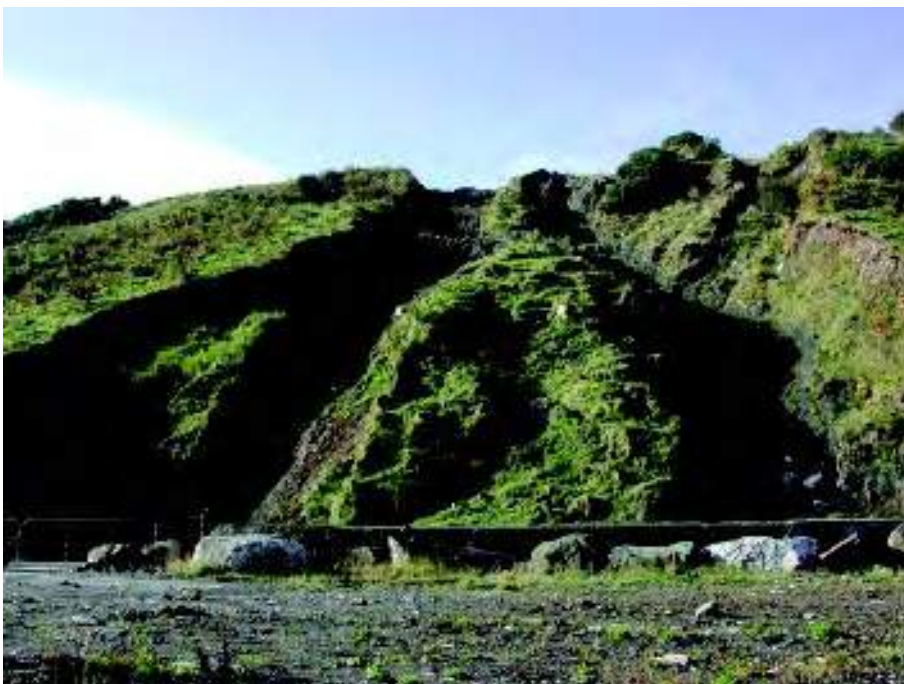
**Plate 7.2** Mudslide at Minnis North, Co Antrim. (Crown Copyright)

Mudflows and debris flows constitute another distinct and significant hazard along parts of the Antrim Coast Road (A2). The mudflows take the form of often catastrophic flows of liquified mud (Waterloo Mudstone Formation, Jurassic) and other debris. These flows have periodically blocked the road at Minnis North [D339 137] south of Glenarm (Plate 7.2) and are commonly triggered by ground saturation following periods of heavy rainfall.

Prior et al (1968) describe the principal active mudflows at Minnis North [D339 137], McAuley's Head [D332 147], Straidkilly Point [D300 168] and Garron Point [D286 252]. The flows are composite, each consisting of a "bowl slide", "flow track", and a composite depositional area. Detailed measurements of the flow movement indicated a significant time lag between rainfall and flow movement. The work concluded that the chief factor in initiating the mudflow was the seasonal accumulation of rainfall leading to saturation of the Jurassic mudstone. Rainfall beyond this saturation was then likely to trigger a mudflow.

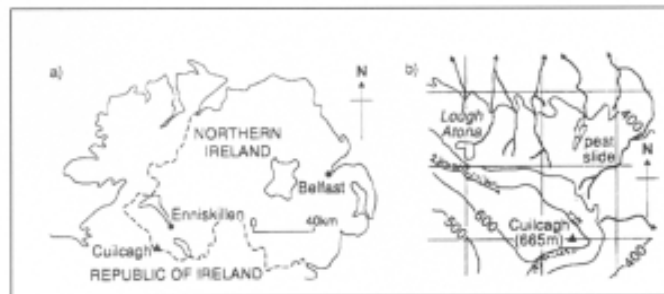
**Fig. 8.2 (a)** Location of the study site at Cuilcagh. (b) Location of the peat slide on Cuilcagh Mountain (1km grid squares; contours in metres). (Dykes and Kirk, 2001).

More recently Dykes, Kirk and Warburton of Huddersfield and Durham Universities respectively, examined peat failures on Cuilcagh Mountain on the Cavan/Fermanagh border, after an event in 1998 (Dykes and Kirk, 2001). More than 30 failures were mapped, some of which were estimated to have travelled over a kilometre. It was suggested that both digging of drainage ditches and possibly burning of peat might have been preconditioning factors in this case, and previous failures were mapped on the same mountain.
